Banff Legacy Trail Flood Repairs

Engineer recognizes using ArmorFlex® would provide cyclists with a safe, grassy slope compared to hard rock.

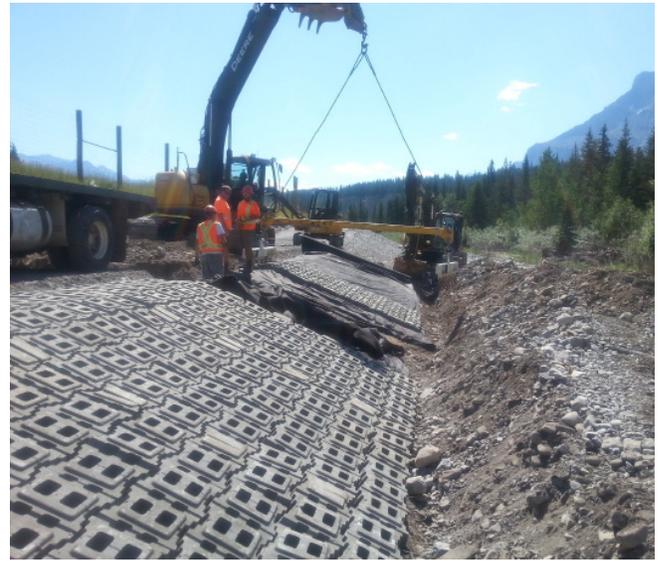
Upon completion, approximately two inches of topsoil was placed over the entire area of AmorFlex and hyrdomulch was then applied to establish vegetation.
