## Westerly Creek Restoration Erosion Control Products

***Erosion Control Blankets and Coir Netted Mats restore a streambank central to community redevelopment.***

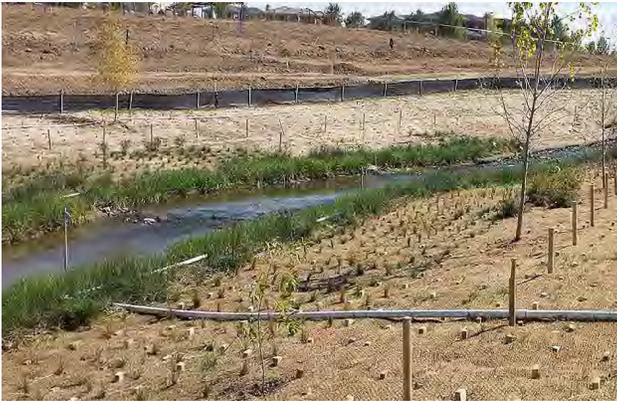
The six acres of ECBs and coir mat was sized and cut in the field to ensure the best fit for the shape of the channel. Since soils were contaminated from past industrial use, they had to be replaced and reshaped along the creek alignment. Total installation took six weeks for a crew of 10 labourers, and included a combination of live planting and seeding to achieve the desired vegetation. A temporary irrigation system was installed to support the revegetation work since crews worked during the peak heat of summer. Standard earthmoving equipment was used, along with 18-inch wooden wedge stakes to secure the mats.
